# FARM ENVIRONMENT PLAN

**Owl Farm**

**72847**

08 January 2019

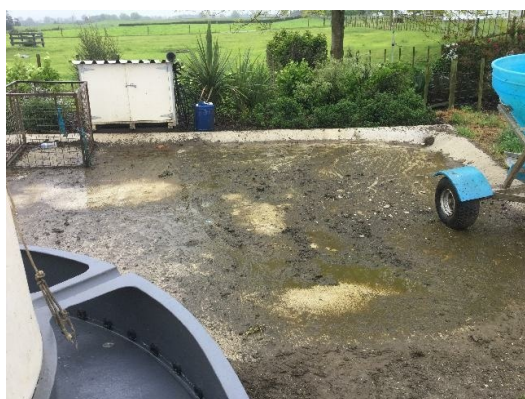
Wash down pad

A nibbed concrete wash-down pad has been constructed for water blasting motorbikes, tractors and implements. This has an overflow pipe in the back corner which directs all waste water back into the effluent system.

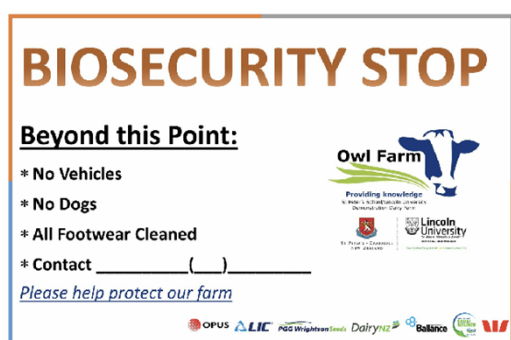
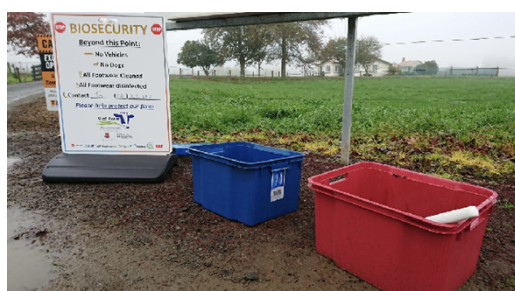
The farm takes biosecurity seriously with the recent outbreak of Mycoplasma Bovis and the fact they have such a large number of guests entering the farm. They have a biosecurity station at the entrance of the farm which requires all guests to disinfect boots before entering the property.

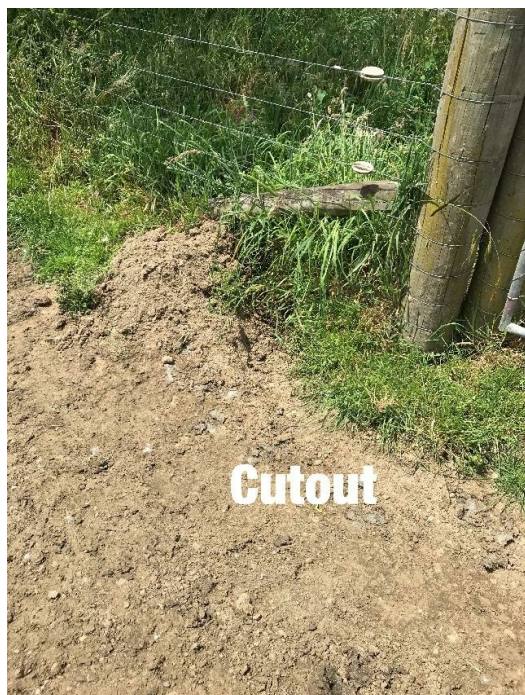
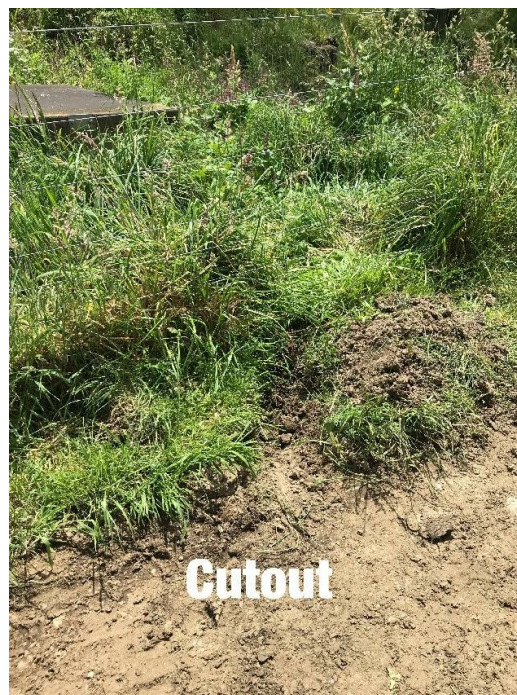
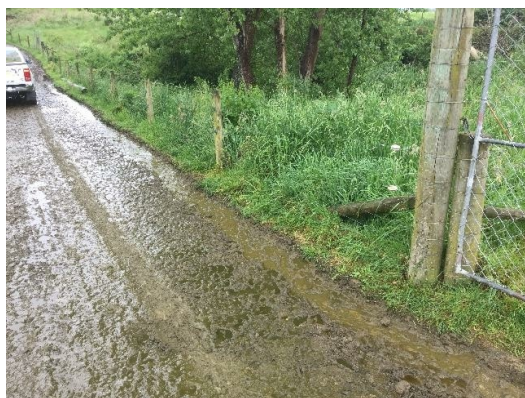
**Contaminant risk type:** Sediment

##### **Dig Cut-out both sides of race - Completed**

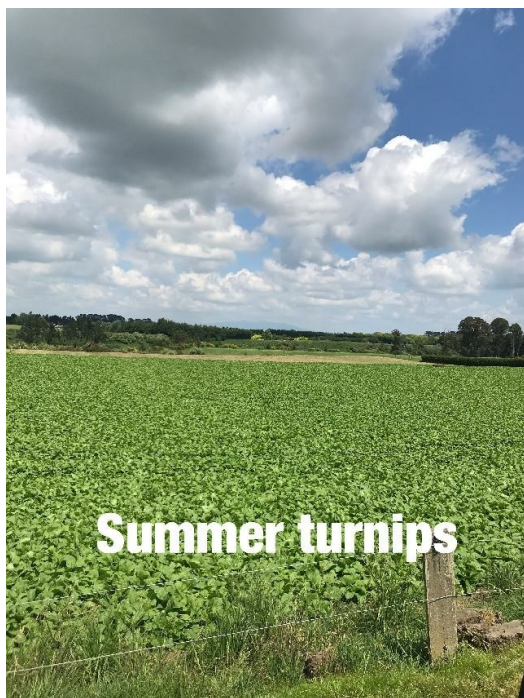
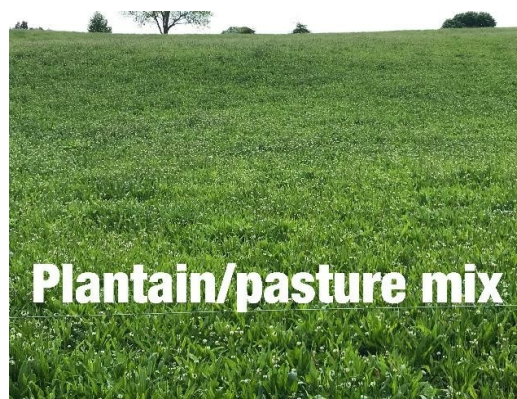
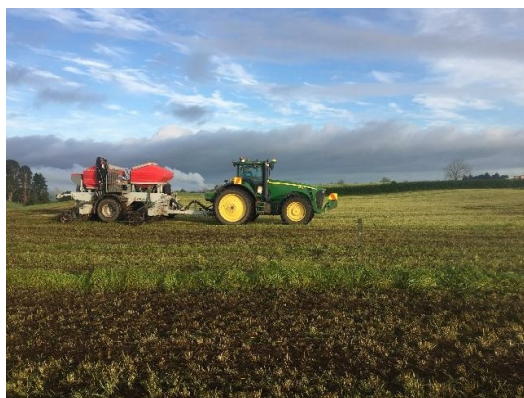
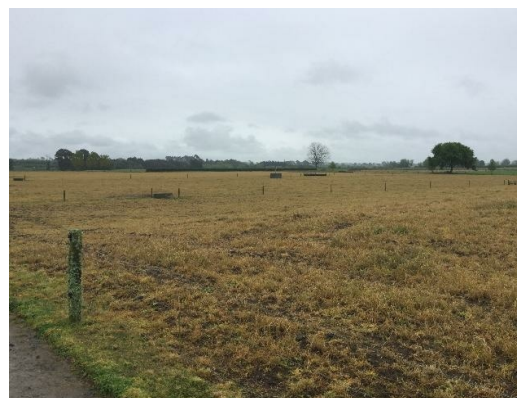
Generally around 8-10% of the milking platform is cropped to ensure high quality summer feed as well as enabling pasture renovation. This summer turnips have been planted. There has also been some planting of a plantain/pasture mix and may in the future be additional maize grown on farm. The farm operates a no cultivation policy meaning all crops are direct drilled. This hasn't had any negative impacts on yields. The farm also avoids cropping steep paddocks which may cause localised erosion during feeding.

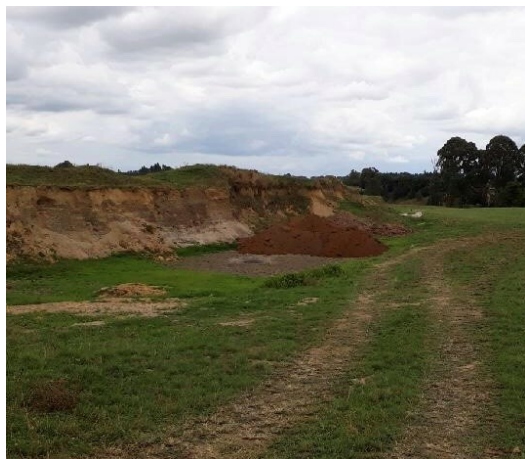
There is an active sand quarry on farm which has been used to form pads for buildings and developments around the School. This quarry has essentially involved the removal of a hill. The angle of the slope face is such that they are not actively eroding and any sediment that does erode is captured in the base of the quarry. This quarry is some distance from any waterways and is not contributing any loss of sediment.

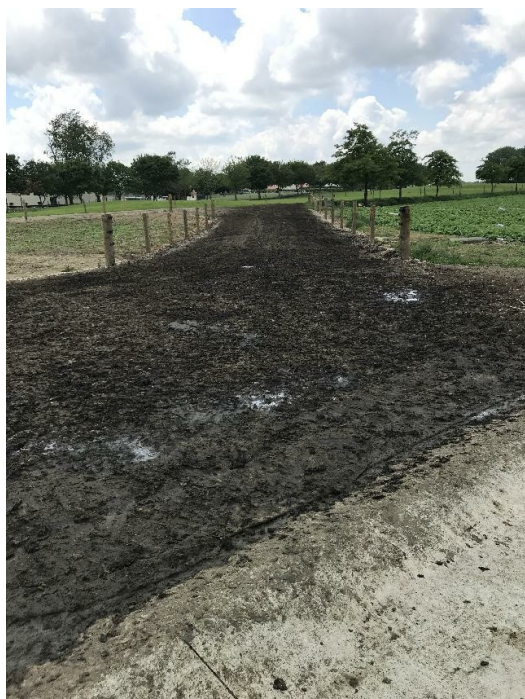
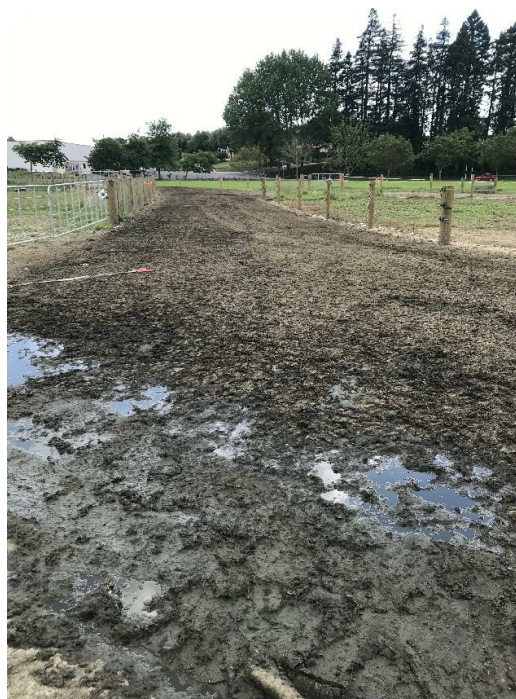
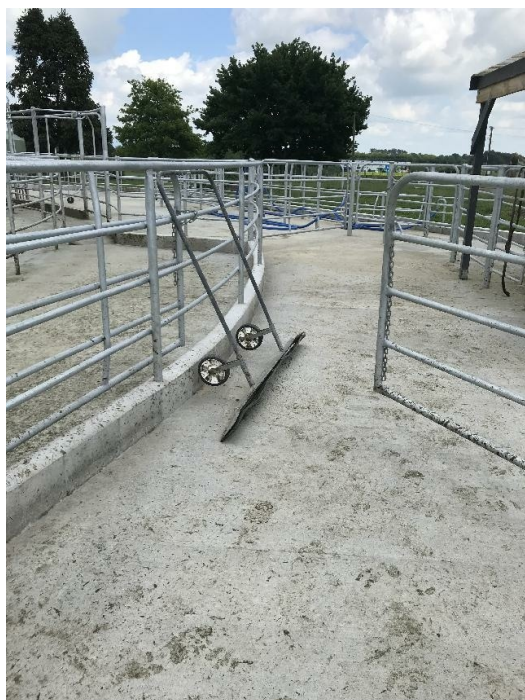
A new yard configuration has led to a change in layout of the entry and exit race. As the farm operates 2 herds there are times the first herd needs to be held in one side of the race until the second herd has entered the yard. As you would expect there is a build-up of effluent around the entry area. Although there is some localised ponding it is all contained and when this builds up the push scraper is used to push solids and liquid back onto the concrete yard where it enters the farms effluent system.

Ensure the scraping of excess effluent build up to the yard continues. Ensure the mechanism for reducing runoff (i.e. bund) remains intact.

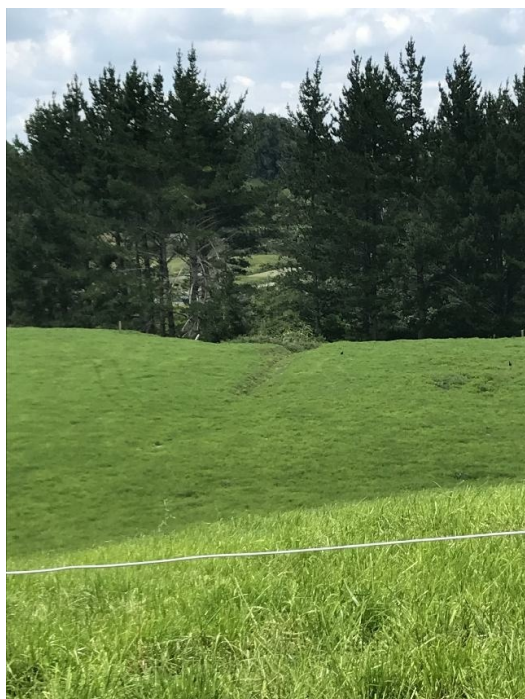
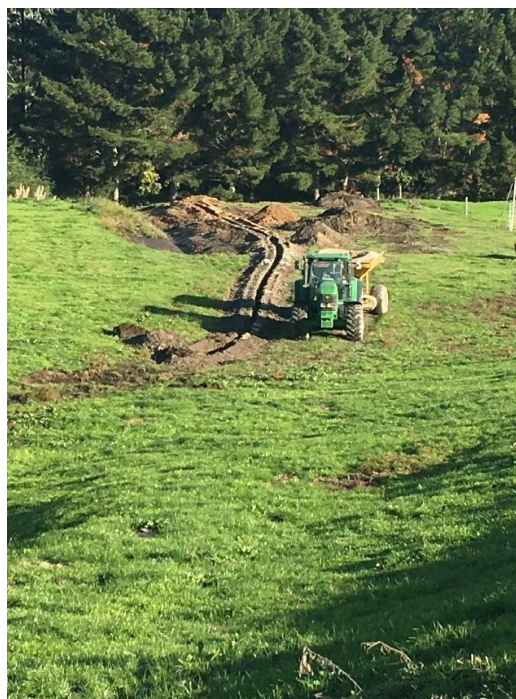
There are a number of springs throughout the farm which come to surface when the water table is high. A series of 3 paddocks on the lower plateau before the farm drops away to the Waikato River has recently been novaflowed to make the area more productive. Nova-flow creates preferential flow-paths and need to be closely managed. Fortunately these paddocks don't receive effluent but care should be taken in applying nitrogen when the soils are actively draining after rainfall events. Fortunately there is a large buffer between the edge of the paddock and the river which will reduce the risk of contamination.

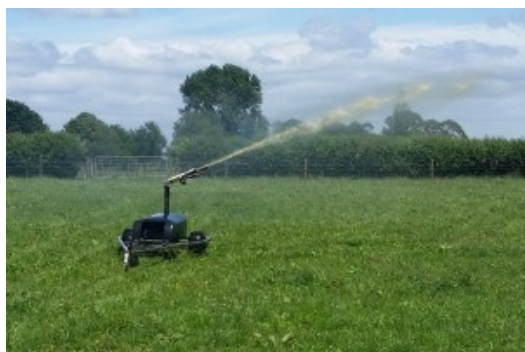
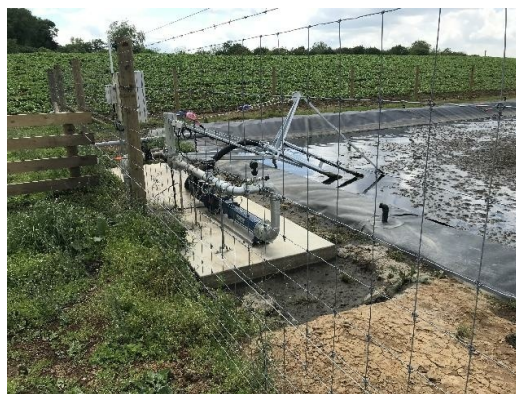
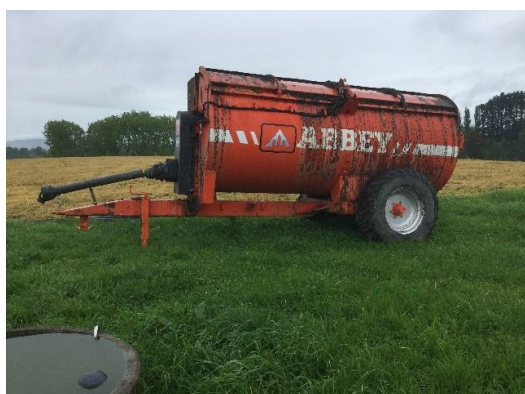
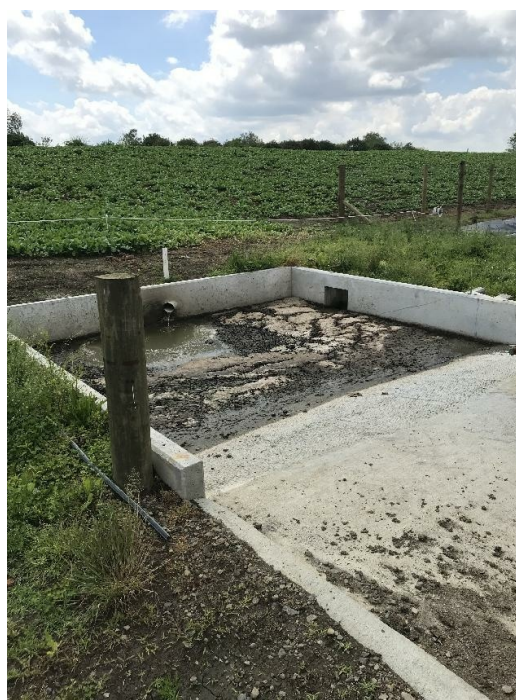
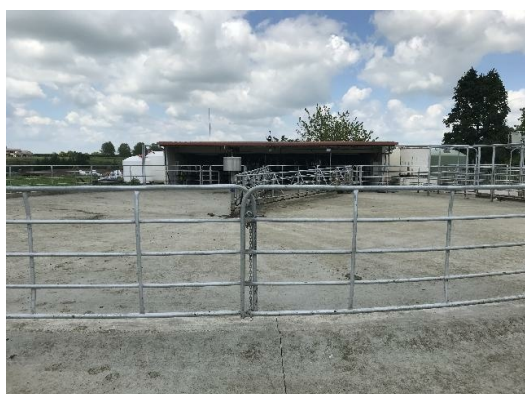
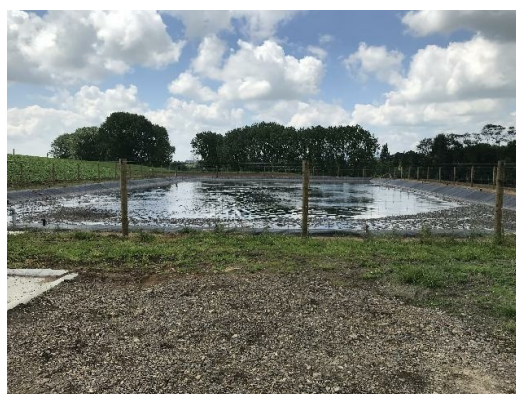
A large stirrer ensures solids don't settle before effluent is pumped to a 62ha effluent block using a Hi-Tech Cobra travelling rain-gun. All equipment is well maintained serviced annually. The use of a weather station means soil moisture can be observed prior to application and although the application depth hasn't been recently measured its expected the irrigator will be applying less than 12mm based on the new mono pump which creates a consistent pressure. Fail safe measures include the use of the Halo system and runs are recorded. Separate soil testing of the effluent block is undertaken to determine K levels.

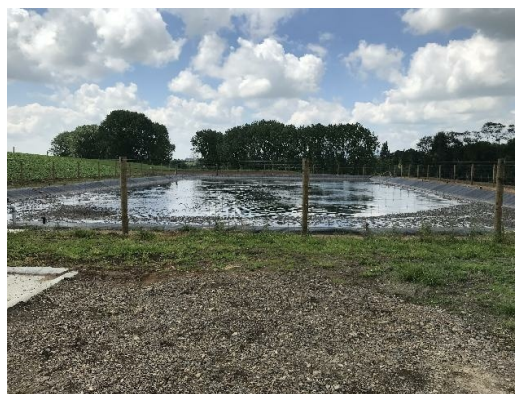
Following a failed Opus Pond Drop Test Owl Farm have constructed a new appropriately sized and sealed effluent holding facility. Using the services of Accredited Dairy Effluent System Designer Davieth Verheij from AgFirst a new system has been appropriately sized using the Dairy Effluent Storage Calculator. With 60m x 31m footprint and a depth of 3.5m the pond has a working volume of 3000 cubic meters which far exceeds the required volume. The location of the pond below the farm dairy allows effluent to enter via gravity. The pond has been lined with HDPE from IS Daming and also has gas venting.

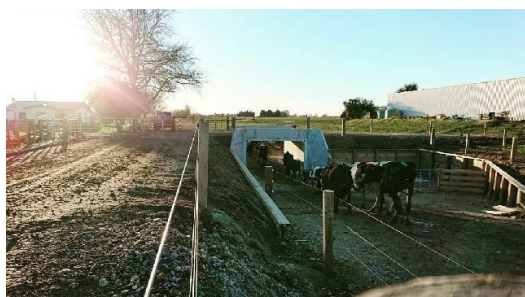
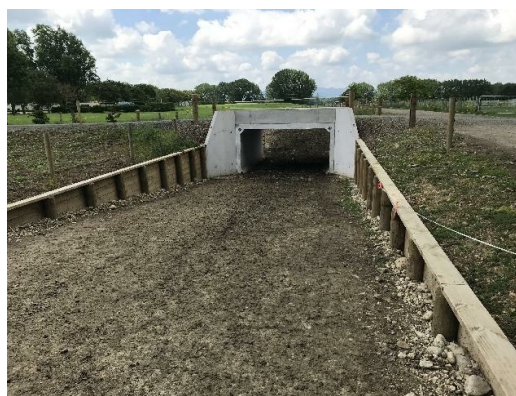
All effluent from both entry points drains to bottom of the underpass where it passes through a sediment trap and sump where it is pumped to the main effluent storage pond using a transfer pump on a float switch.

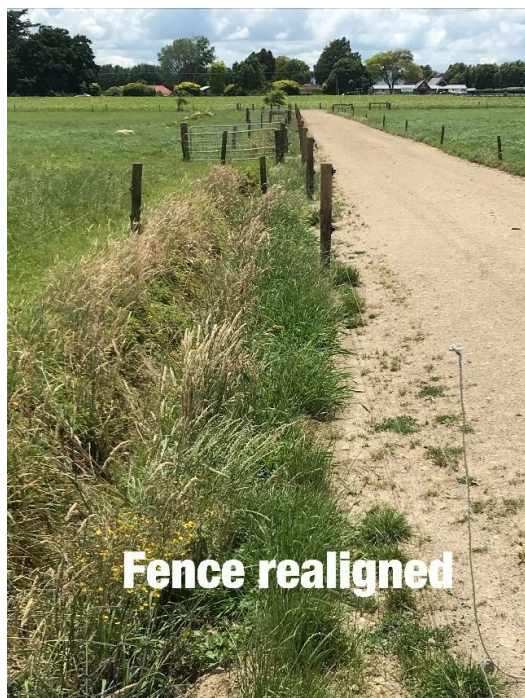
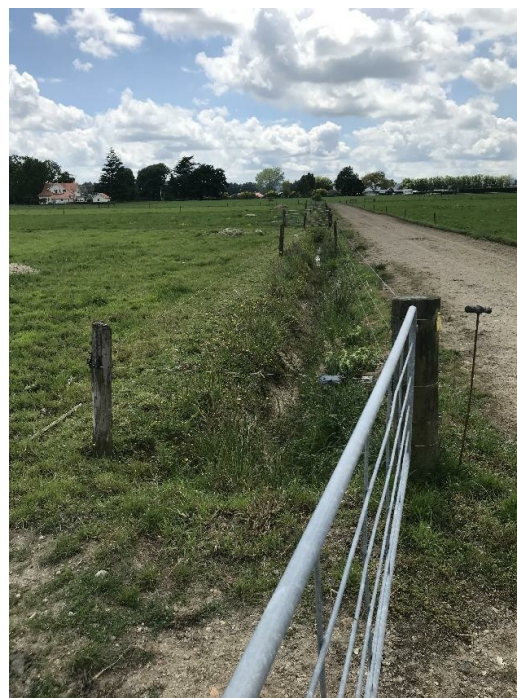
There is a small drain which runs alongside the raceway towards the main drain from the swimming pool. Given the close proximity to the race this drain is susceptible to receiving contaminated runoff from the race which can ultimately enter the drain. The drain is currently blocked off to ensure this doesn't occur but longer term the drain will be shifted inwards to the paddock with current area being planted to act as an effective vegetative filter strip.

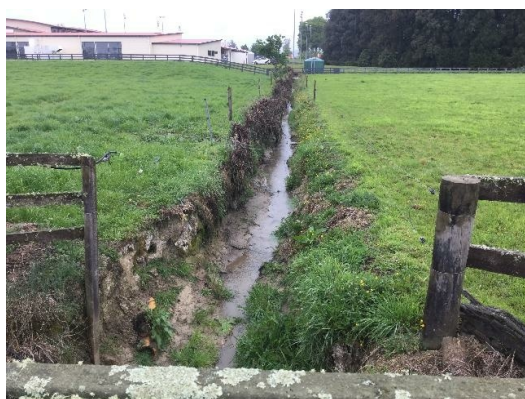
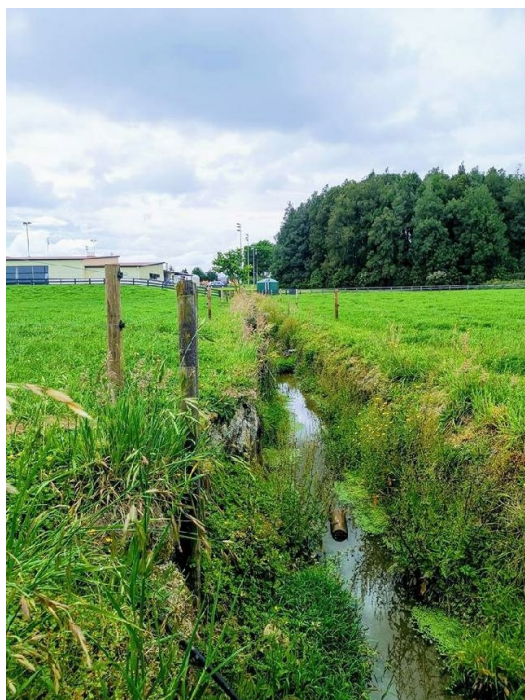
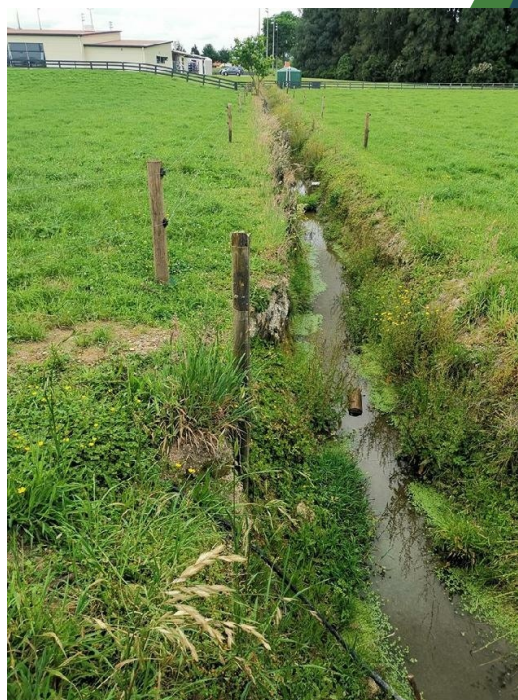
**Vegetation status:** Rank Grass

UPDATE: Fence has been shifted and planting of carex will take place in autumn next year. Continue to monitor the banks further down the waterway towards the boundary to determine whether this requires fence relocation and planting as well.

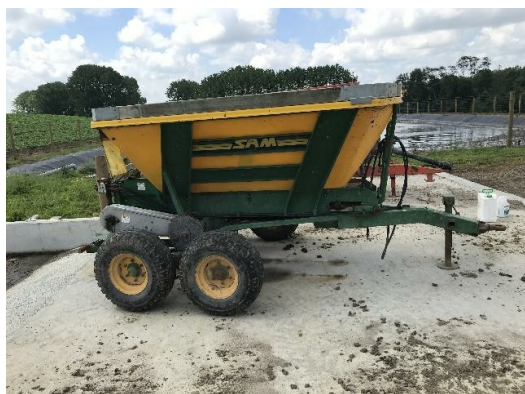
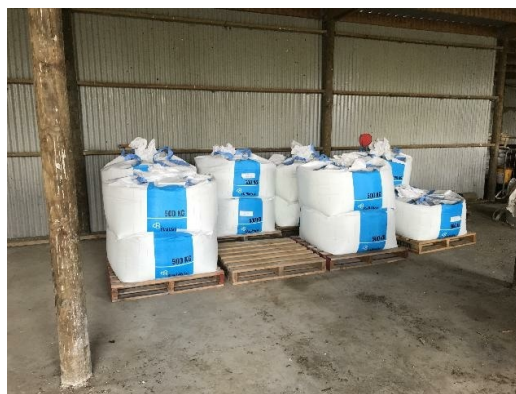
### IMAGES:

Owl Farm has a self-imposed cap of 150kgN/ha/yr with the majority of nitrogen fertiliser spread themselves through the use of the Sam spreader on farm. All applications are tracked using TracMap in the tractor and use of the weather station means soil temperature and moisture can be taken into account prior to applications being undertaken.

All nitrogen fertiliser is delivered in 500kg bags and stored on a concrete floor in the implement shed.
